VAJRA

CHISEL QUALITY GUARANTEE STANDARD

Quality guarantee standard

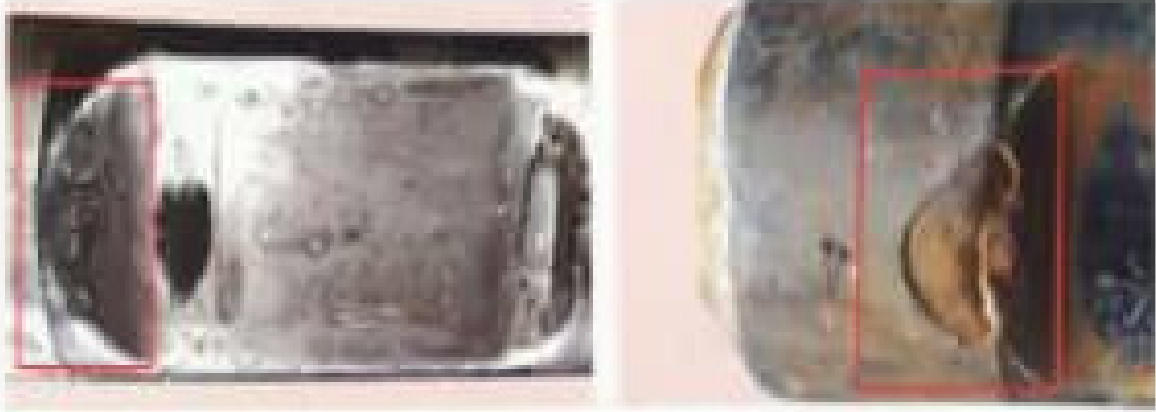
Empty Hitting

NOT IN WARRANTY

If the pointy part of the chisel isn't firmly on the rock, it might slide on the broken thing. This means the strong hit doesn't go well into the rock through the chisel. It can make the chisel hit the tool pin, breaking or damaging it.

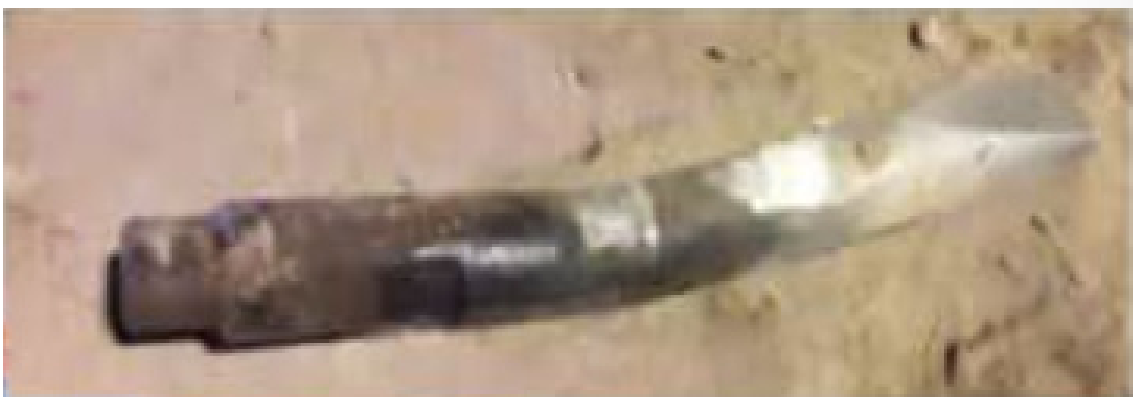
Chisel Bending

IN WARRANTY

The picture above displays a chisel that's bending because the manufacturer didn't heat-treat it enough. If it's a regular hardness chisel, it can break easily. The chisel isn't very hard, but it still bends because it has some strength. This happens when the heat treatment isn't enough, but it can be fixed.

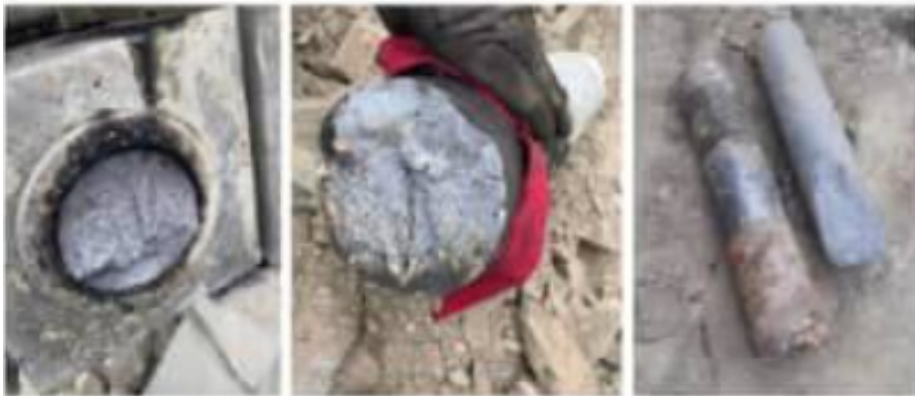
Fracture

NOT IN WARRANTY

To make the chisel stronger, it needs to undergo a heat treatment, making it harder. During use, try to keep the chisel at a vertical angle for better results. This issue often happens when the excavator's arm is used to pull apart a broken object. In this situation, the chisel is already inside the broken object. The operator pulls with the excavator's arm to separate the broken parts. If the pulling force is stronger than what the chisel can handle, it might break. The break usually happens at the outer bushing opening or the chisel's pivot point.

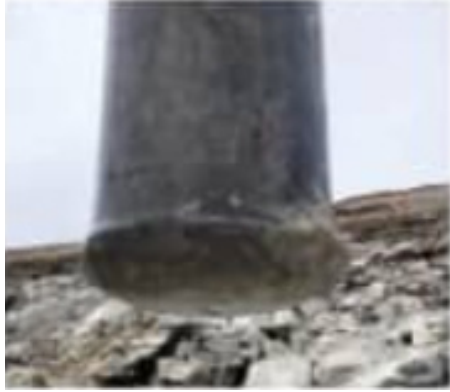
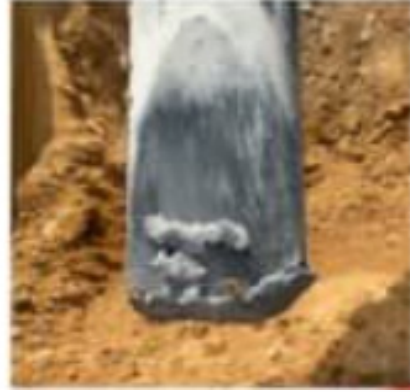
Roiling Edge

NOT IN WARRANTY

If the chisel is used a lot in a tough environment, and it keeps hitting for too long, the front part of the chisel can get really hot. This makes the chisel soft because of a process called decarburization, and it can develop a mushroom shape under strong hitting. When using the breaker, be careful not to hit the same spot for more than 30 seconds continuously. If you can't break the target after a while, try a different spot. We won't accept claims for this issue.

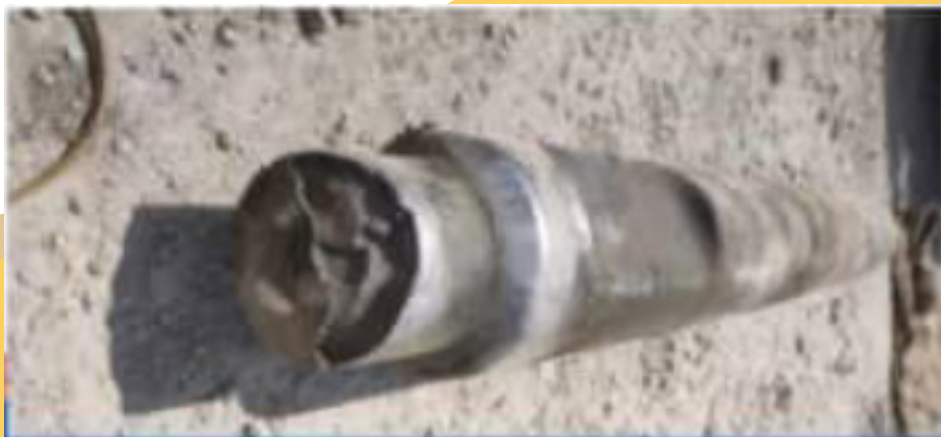
Partial Hitting

NOT IN WARRANTY

If the bush set or piston is worn out and old but still being used, it can lead to a problem called partial hitting. When the chisel is installed, there's a significant looseness, and it can't stay in the correct working position. This means the hitting surface of the piston and the chisel is often not parallel, causing the chisel to miss. This misalignment can result in breaking part of the chisel or piston's end edge, and the sleeve position can wear out due to long-term irregular force. We don't cover this issue in the warranty.
